## AES January 28, 2015 Site Visit Photo-Documentation

# Highlights on the Facility Walkthrough

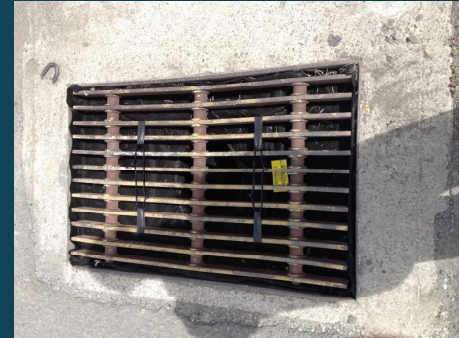
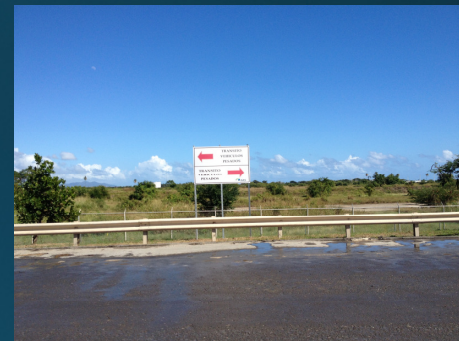
- *Walkthrough to check on pending implementation of BMPs, Sampling Points, Yards, Aggremax<sup>™</sup> Pile, Coal Pile, Limestone Dome, and Ponds*
- *Crushed stone re-application observed throughout*
- *Water mounted-tank truck sprinkling water on internal roads*
- *Mechanical Sweeper (not as effective as water application)*
- *Inlet Protection*

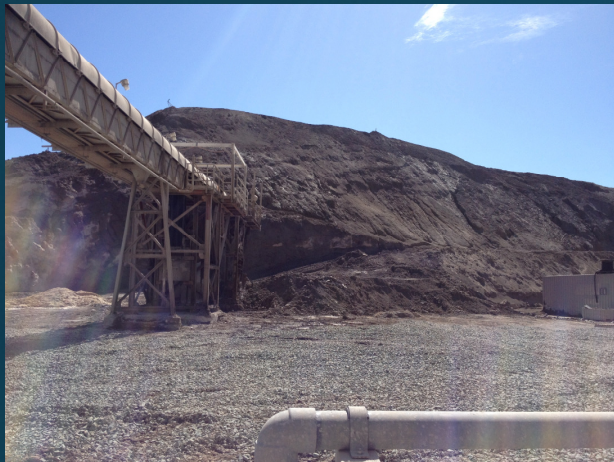
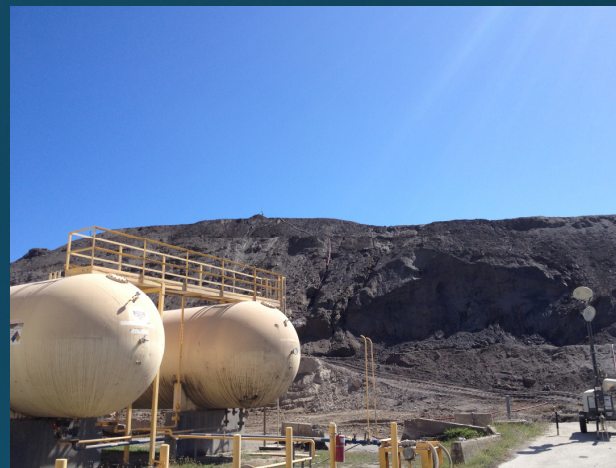
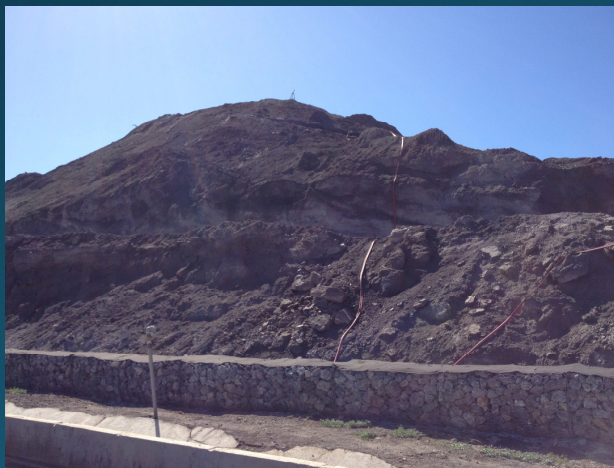
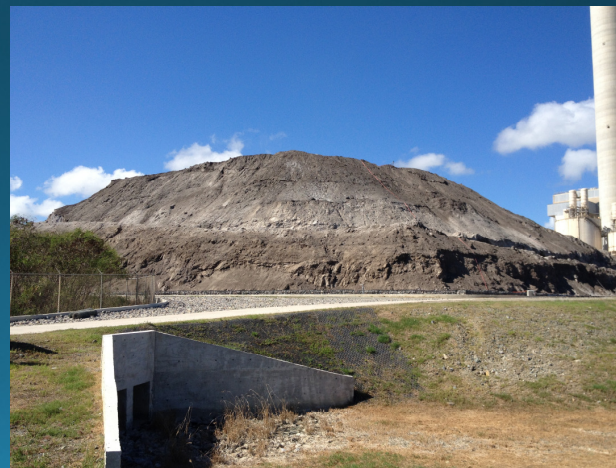
# Aggremax Pile

- *Aggremax pile is significant lower than when was last seen during the December 2, 2014 visit*
  - *150,000 tons removed between June 2014 and November 2014*
  - *More than 260,000 tons removed in 2014*
  - *More than 220,000 tons removed between November 2014 and January 2015*
  - *Completed installation and operation of 9 sprinklers for Aggremax pile water irrigation at a \$350,000 cost.*
  - *Sprinklers were observed in operation during the Walkthrough.*
  - *Water Tank-Mounted Truck also use to wet the pile and other areas*

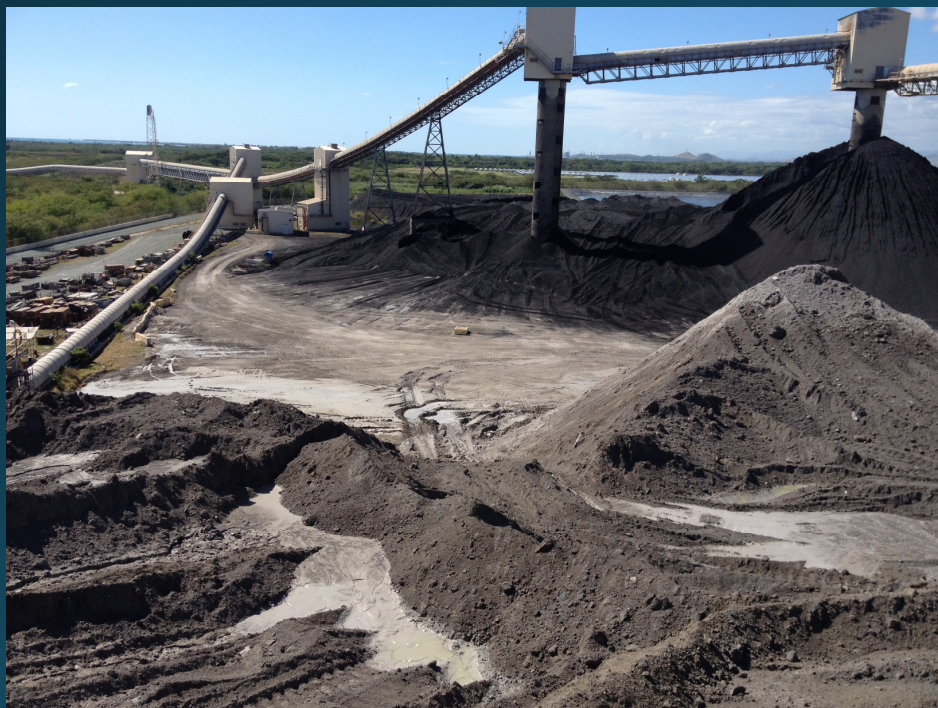
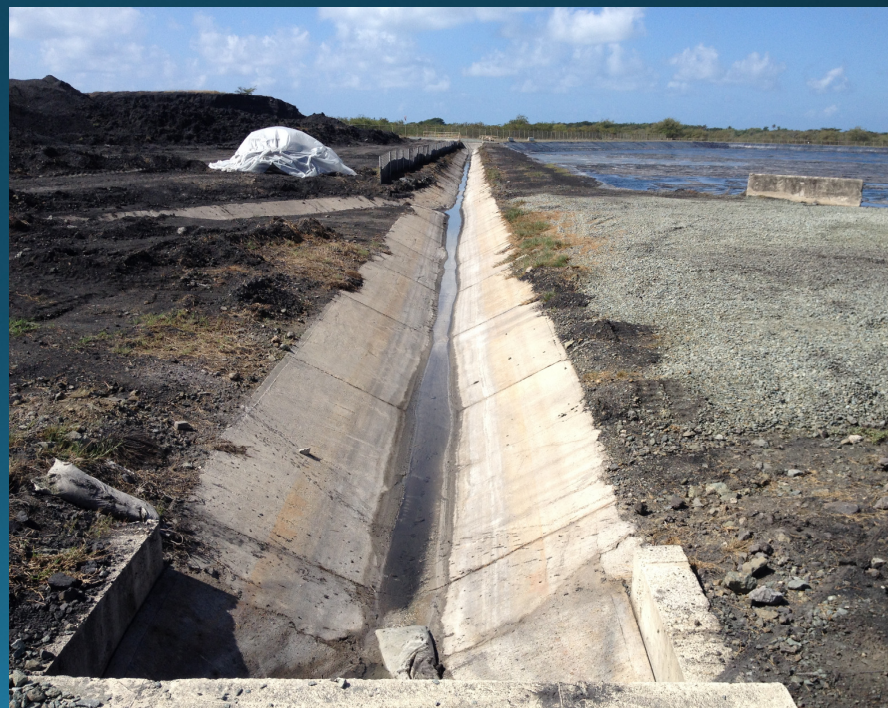
- Stabilization of certain areas within the coal pile runoff pond hydrological areas

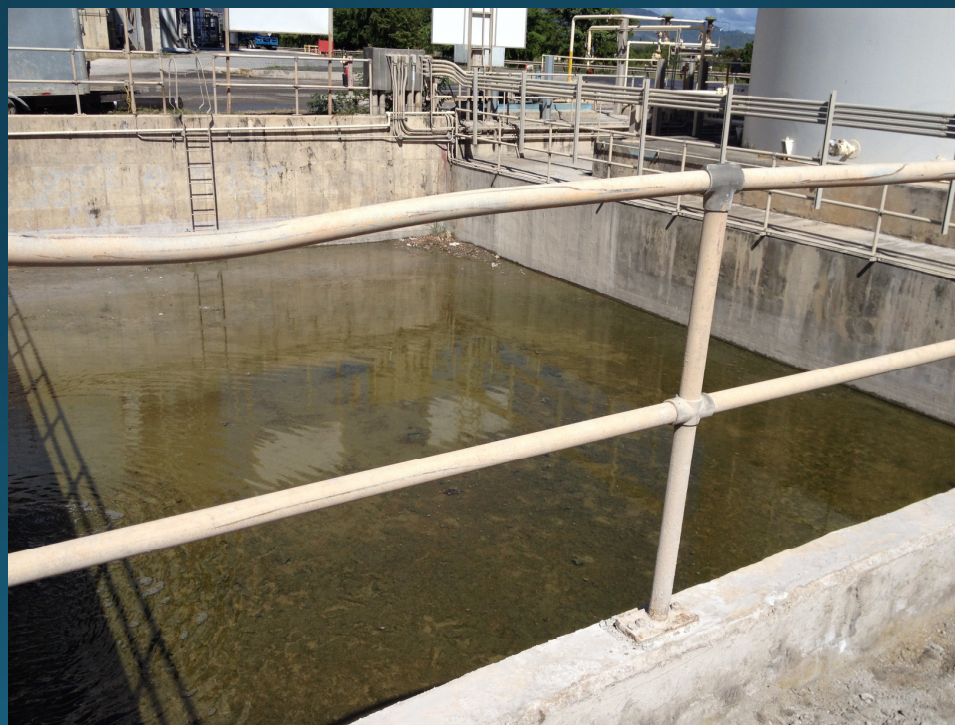
- Housekeeping – Diesel Tank Secondary Containment
